# UNDERWATER BRIDGE INSPECTION REPORT

STRUCTURE NO. 3575

FORD PARKWAY

MISSISSIPPI RIVER

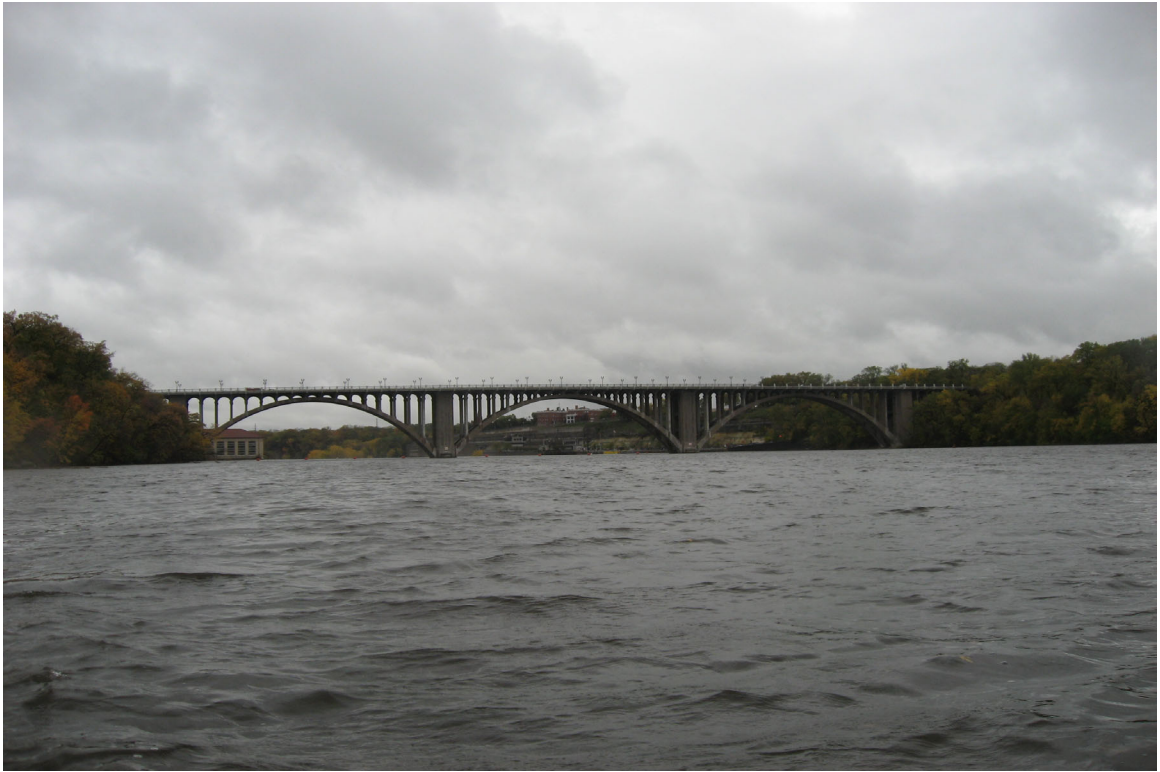
Photograph 1. Overall View of Bridge, Looking Southwest.

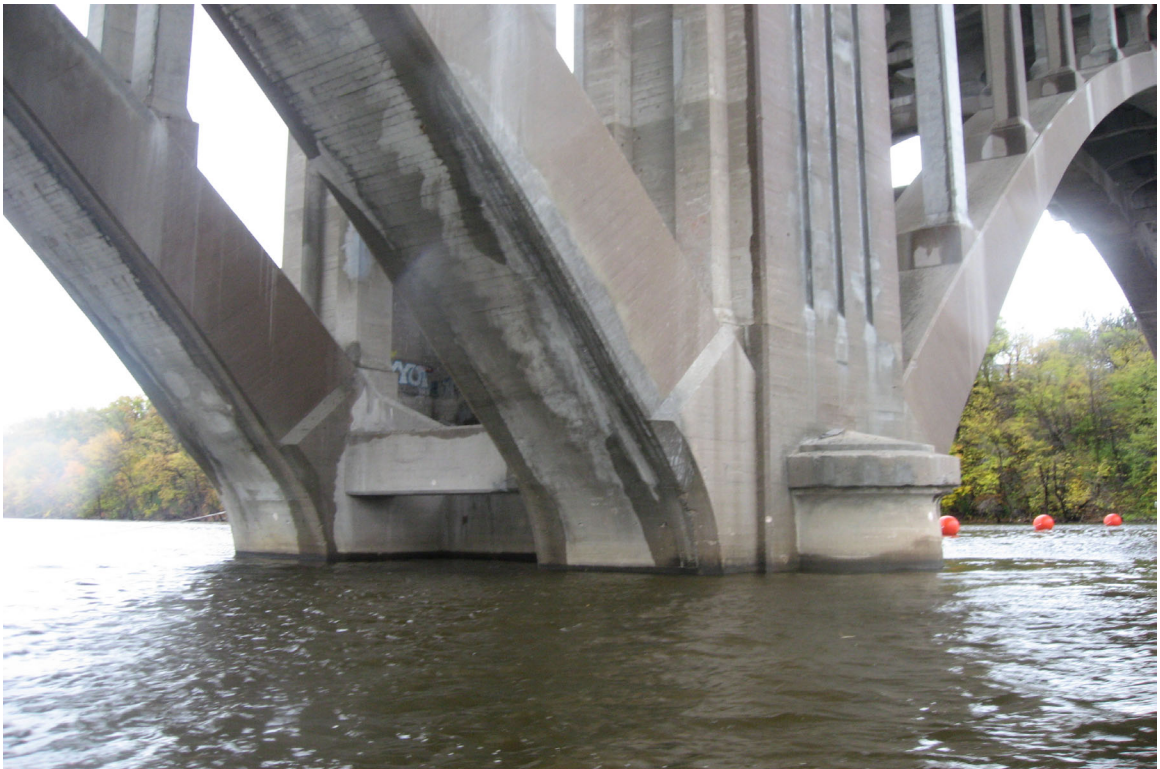
- (B) The footing was exposed around the entire perimeter of Piers 8 and 9. Typically, the exposed portions of the footing exhibited heavy scaling with 1 to 2 feet of penetration related to section loss.

- (C) Undermining of the footing was observed at the northeast corner of Pier 8, with a cavity that was 3 feet long by 1 foot high with up to 1 foot of horizontal penetration.

- (D) Localized scour depressions were observed around the upstream end of Piers 8 and 9 with typical depths of 5 to 10 feet. Concrete rubble with protruding reinforcing bars was found at the base of the scour depressions, as well as around much of the piers, appearing to have found its way there as the result of recent concrete rehab at the bridge.

Photograph 2. View of Pier 8, Looking Northeast.

- (A) Monitor footing exposures at Piers 8 and 9 and undermining at Pier 8 during future underwater inspections for further vertical face exposure and/or undermining.
- (B) Reinspect the submerged substructure units at the normal maximum recommended (NBIS) interval of five (5) years.

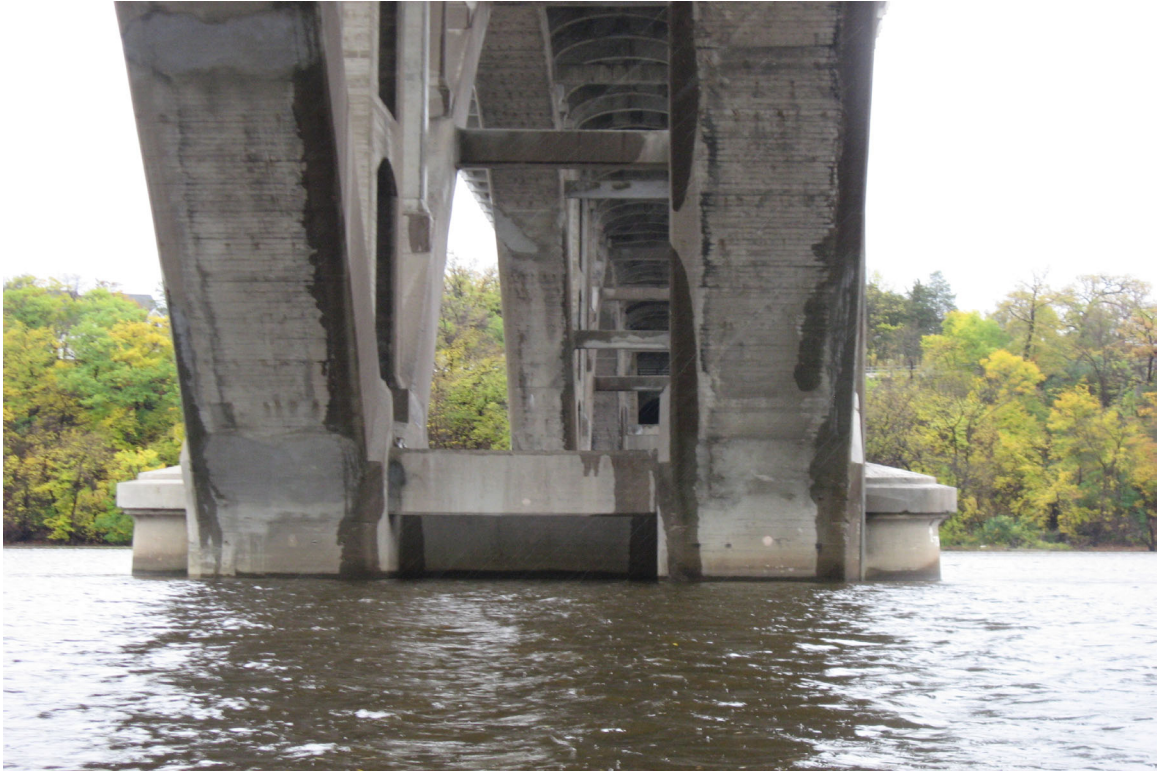
Photograph 3. View of Pier 9, Looking East.

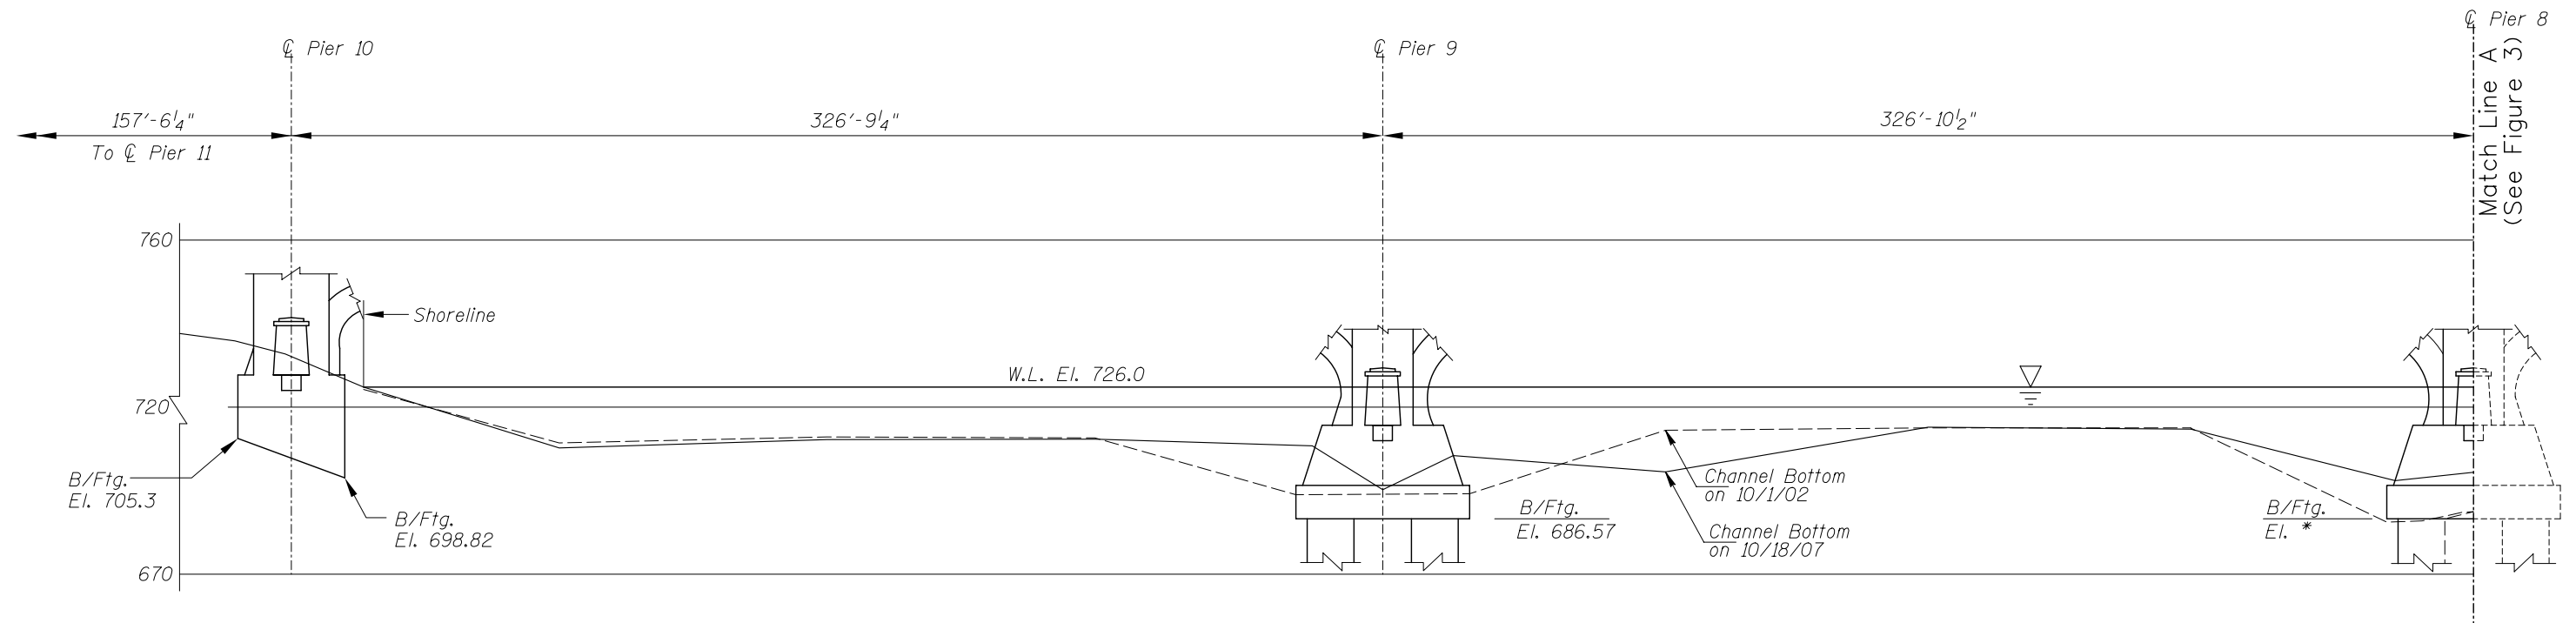
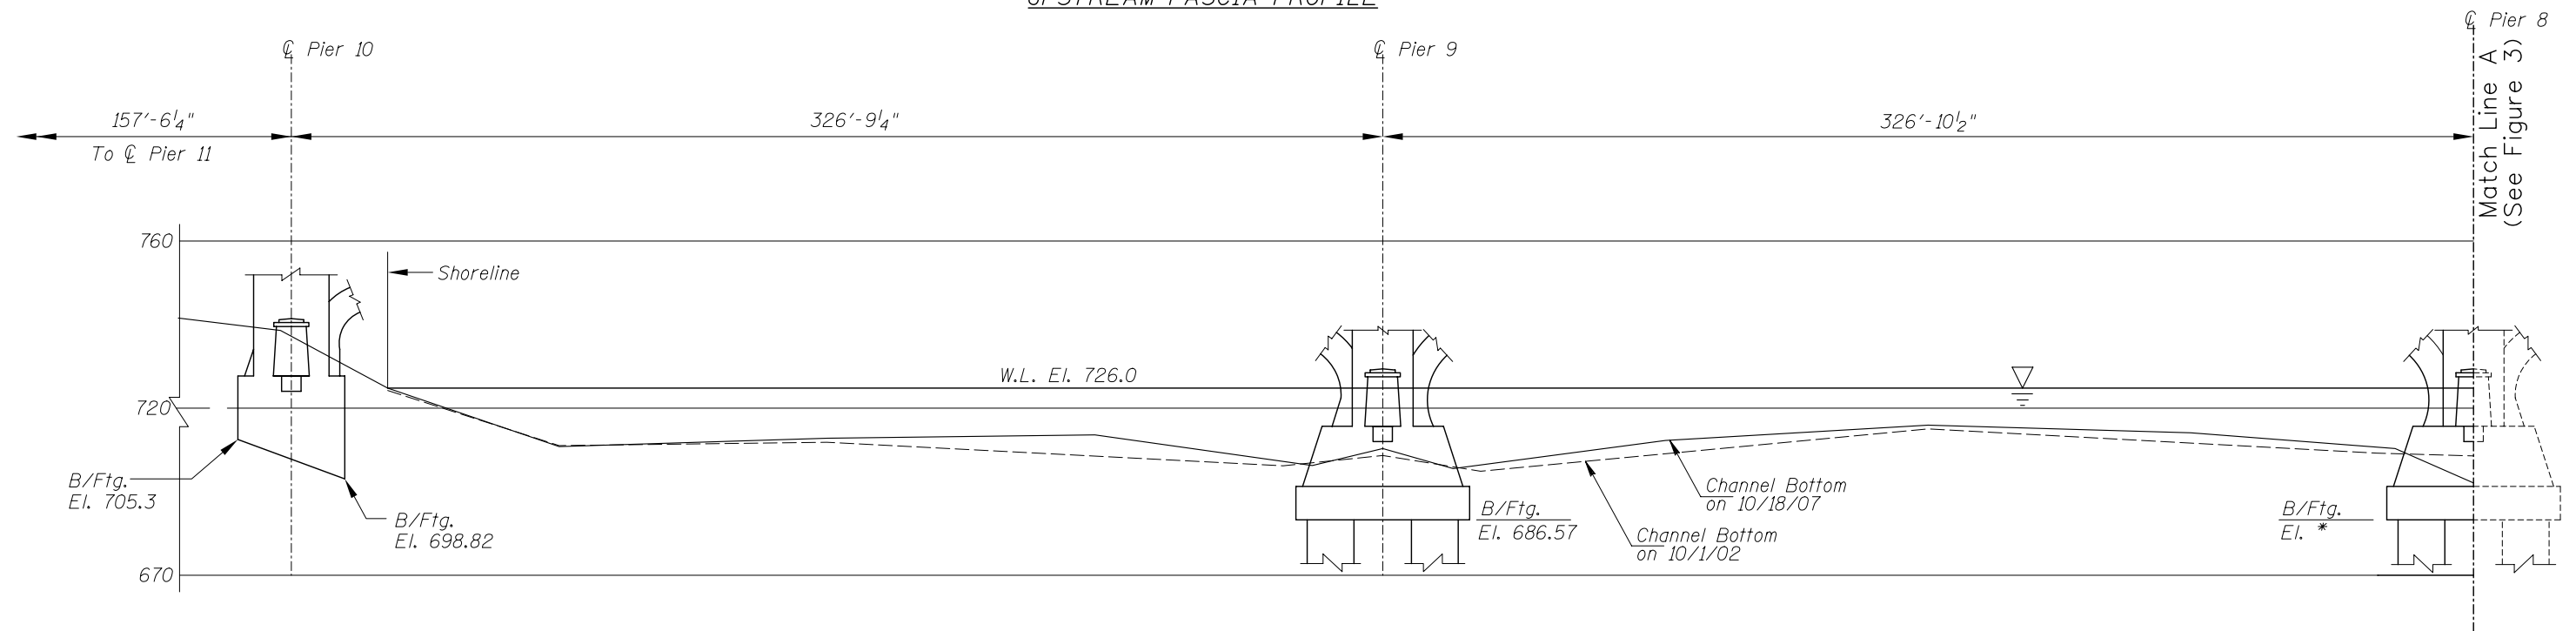
STRUCTURE NO. 3575  
OVER THE MISSISSIPPI RIVER  
DISTRICT 9, RAMSEY COUNTY  
**UPSTREAM AND DOWNSTREAM  
FASCIA PROFILES**

\* The bottom of footing elevation noted on the Design Plans does not correspond to the soundings and/or undermining detected at the time of the underwater inspection.

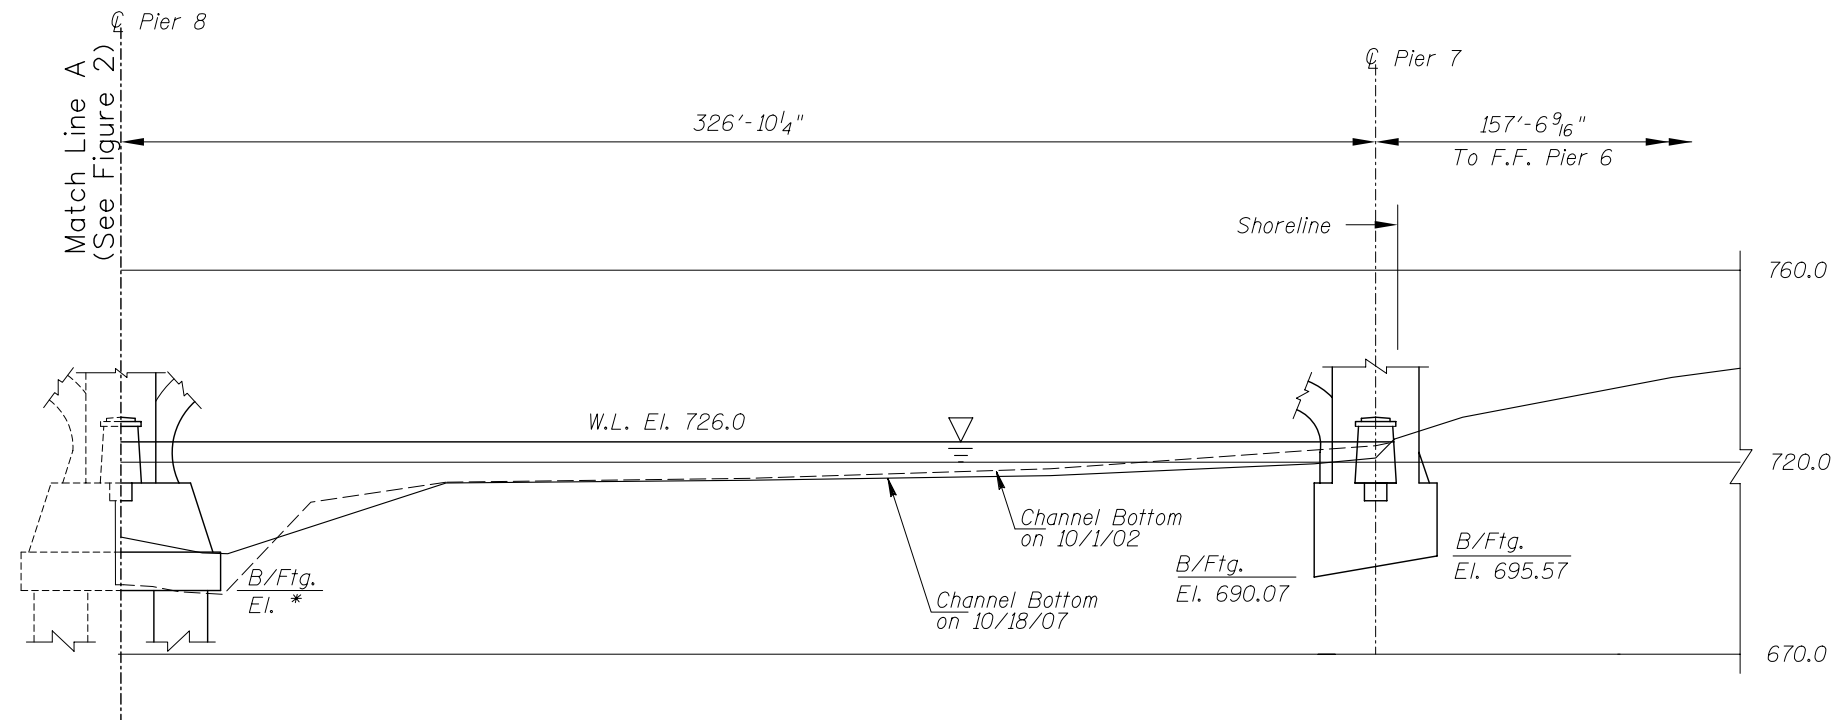
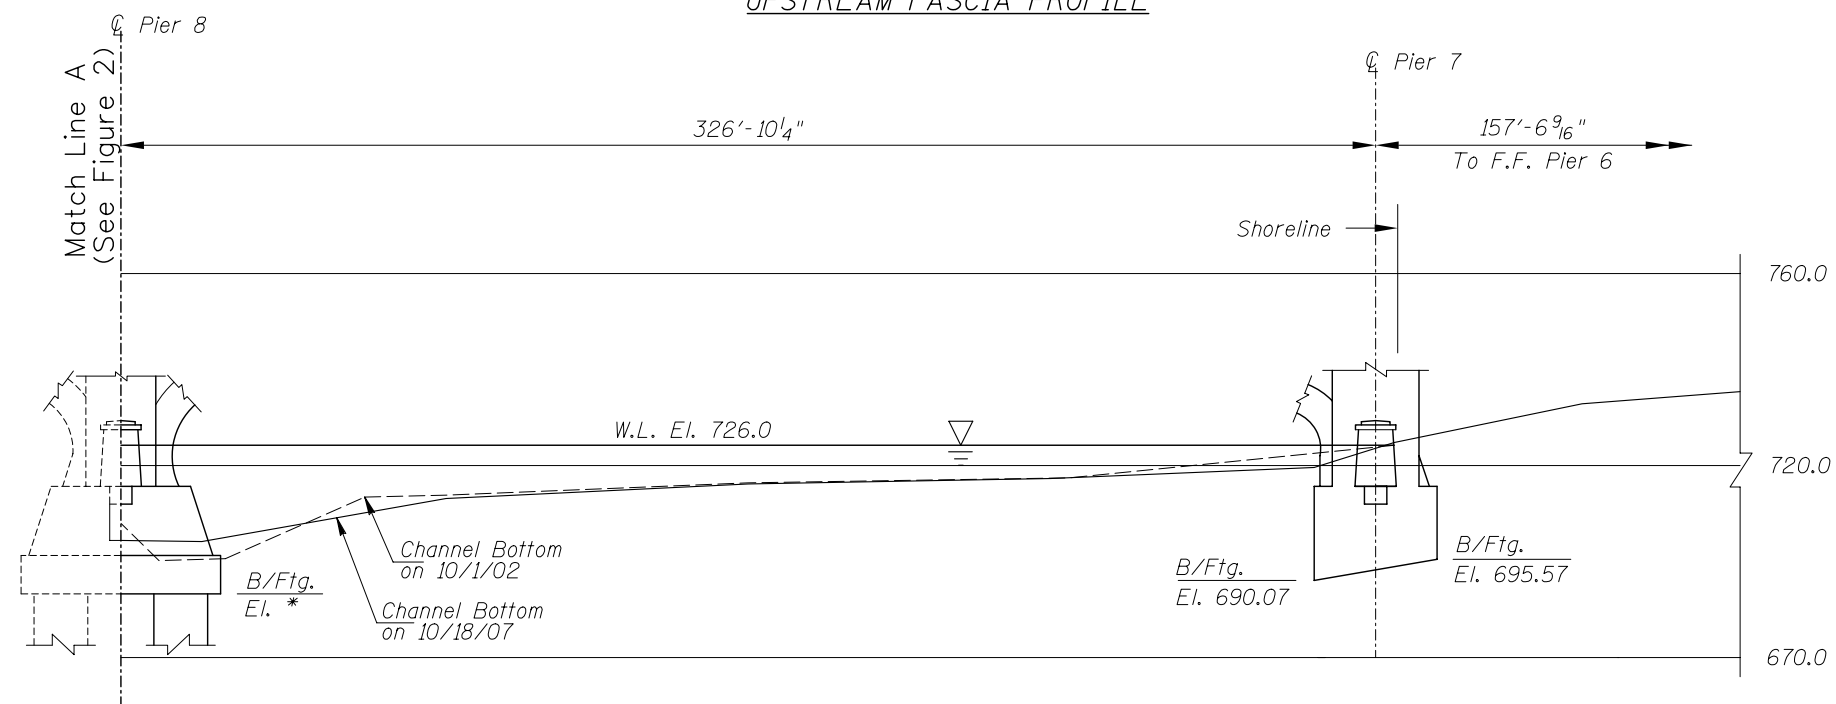
STRUCTURE NO. 3575  
OVER THE MISSISSIPPI RIVER  
DISTRICT 9, RAMSEY COUNTY  
**UPSTREAM AND DOWNSTREAM  
FASCIA PROFILES**

\* The bottom of footing elevation noted on the Design Plans does not correspond to the soundings and/or undermining detected at the time of the underwater inspection.
